Challenging the Norm of Minimums: A Case Study of ADA Design Standards on the University of Nebraska-Lincoln Campus

A THESIS

Presented to the Faculty of
The Graduate College at the University of Nebraska
In Partial Fulfillment of Requirements
For the Degree of Master of Science
Major: Architecture
Under the Supervision of Professor Lindsey Bahe
Lincoln, NE
May 2018

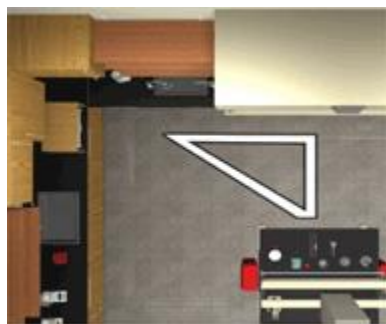
Figure 3: The laboratory work triangle. Photograph. Retrieved from

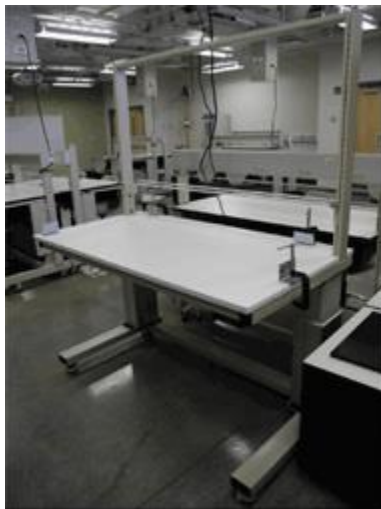
The first component of the laboratory work triangle considered for modification was the work bench. Typically, labs had stationary tables but a height-adjustable table proved to be the best solution to improve accessibility, with power controls to raise and lower the work surface,

Figure 4: Height adjustable work bench with power controls.

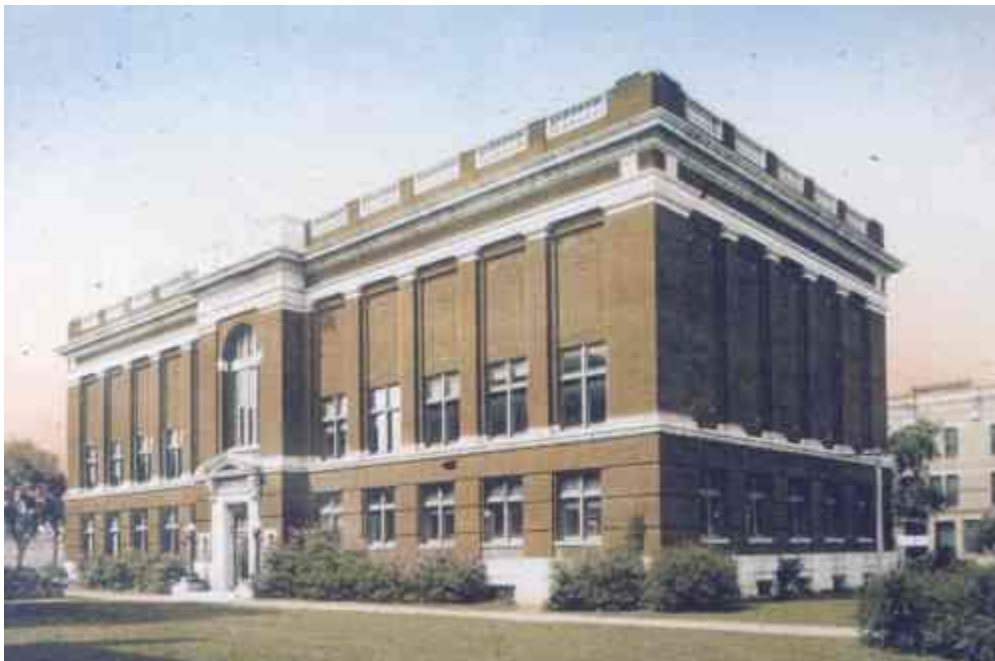
Figure 10: College of Law Building. Photograph. Retrieved from: <http://historicbuildings.unl.edu/index.html>

The College of Law building, pictured left, was constructed in 1912 by Berlinghof and Davis. The building would undergo various updates throughout the

1920s and 1950s, including the addition of library stacks to the North side of the building in 1957 (Logan Peters, Rickel, & Bajaber, 2005). Quite soon after Architecture Hall was established on the National Register of Historic Places in 1975, the Old Library and College of Law buildings would undergo a \$4.4 million renovation including the addition of a connecting “link” to combine the two historic buildings into one facility for the College of

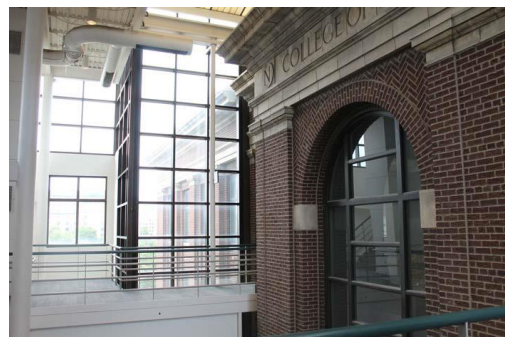
Figure 11: Interior view of the "link" connecting Architecture Hall to the College of Law Building. Photograph. Retrieved from: <https://nufoundation.org/-/unl-college-of-architecture-college-of-architecture-building-for-the-future-fund-01139350>

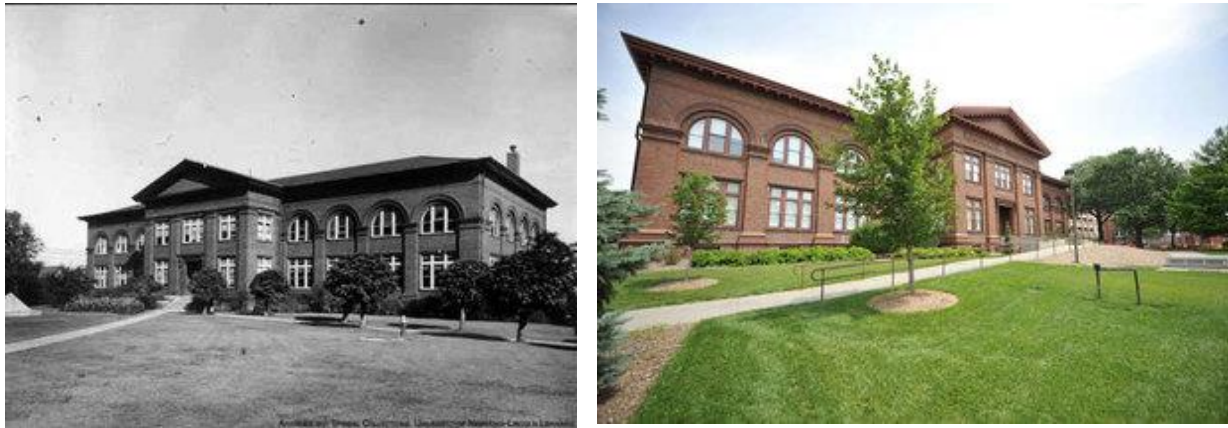
Figure 12: Left: Historic Richards Hall, known then as Mechanical Engineering Laboratories. Right: Present day Richards Hall. Photograph. Retrieved from: <http://historicbuildings.unl.edu/index.html>

Richards Hall was constructed in 1908 by F.P. Gould and Sons, originally called the Mechanical Engineering Laboratories. Students petitioned the University in 1944 to rename the building Richards for C.R. Richards who was the first Dean of the College of Engineering on campus (Logan Peters, Rickel, & Bajaber, 2005). Originally constructed as a hub for practical applications/experimentation for engineering, the building now functions under the College of Arts and Sciences, primarily as art studios.

This building is the only one of its style on the campus, as it was described as “Roman-Doric” at the time of construction, which is known today more commonly as Italianate or Renaissance Revival (Logan Peters, Rickel, & Bajaber, 2005). Richards Hall underwent a large renovation in 2000 to better accommodate the arts facilities. As is visible in the side by side images in Figure 12, the south entrance staircase was replaced with a ramp- a move of Universal Design which makes this building’s access one of great equality for all people.

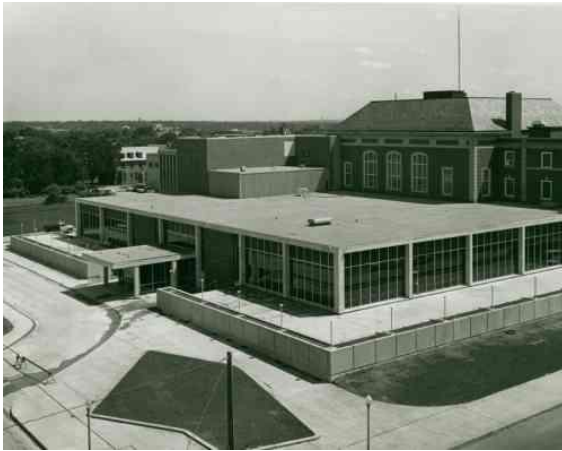
Figure 15: 1959 North addition to the Union. Photograph. Retrieved from: <http://historicbuildings.unl.edu/index.html>

As shown in Figure 15 above, the 1959 addition to the Union strayed from the vernacular to take on the mid-century modern style of the time. The 1969 addition accommodated the rapid

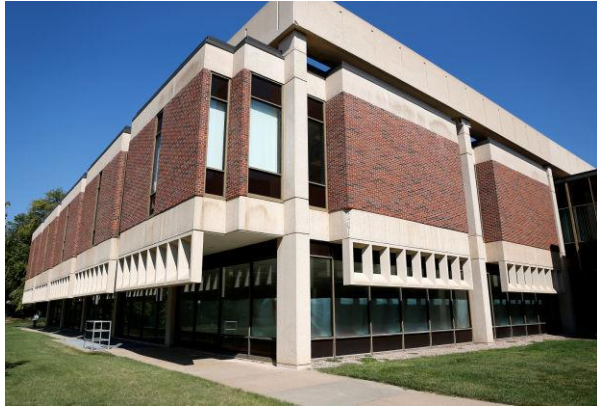
Figure 19: Love Library North, constructed in 1972 and updated in 2016. Photograph. Retrieved from: <https://libraries.unl.edu/>

This building was another in the era of Davis & Wilson Architects, with limestone and brick used to resemble other buildings of the time. An addition to the facility was added in 1972, which is now known as Love Library North. This area was the focus of the building audit

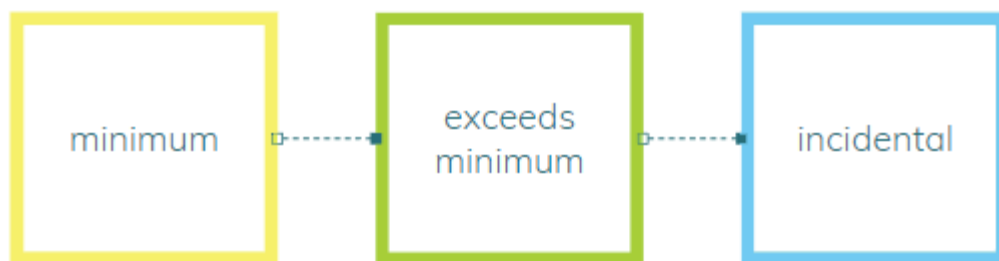
Figure 39: Three main categories of data points. Points determined Not Applicable were not included in analysis of the data set. Created with Google Slides.

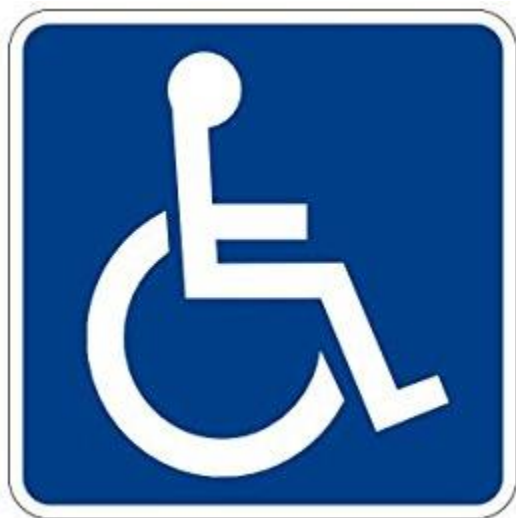
Figure 47.

Additionally, the participant researcher was unable to locate signs indicating the locations of accessible entrances from inaccessible entrances. An example of such a sign is shown in

Figure 47: Symbol used on campus to indicate the location of an accessible entrance from an inaccessible entrance. Photograph. Retrieved from: <https://www.amazon.com/Handicap-Access-Sticker-Window-Decal/dp/B0075VU64M>

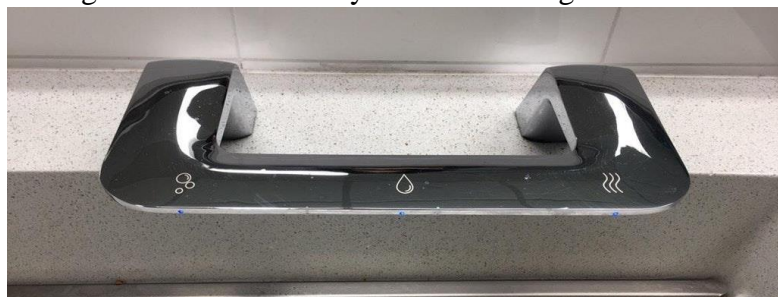
Figure 48: Updated lavatories add excellent universal design to the Union restrooms. Photograph. Retrieved from: <https://news.unl.edu/newsrooms/today/article/summer-construction-new-buildings-and-updates/>

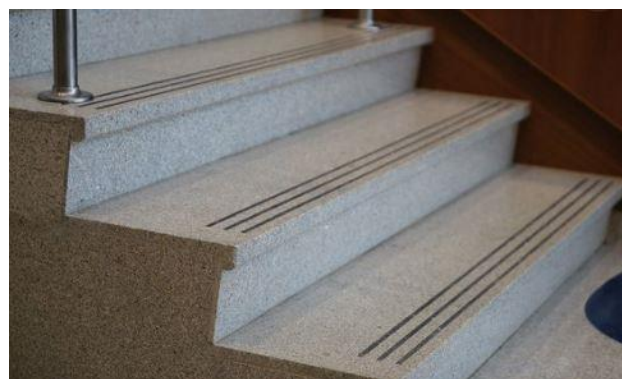
Figure 52: Example of non-slip strips added/integrated to a typical stair surface like terrazzo. While this example shows three strips, buildings on campus only have two. Photograph. Retrieved from: http://terrazzco.com/treads-risers/?utm_content=buffer90345&utm_

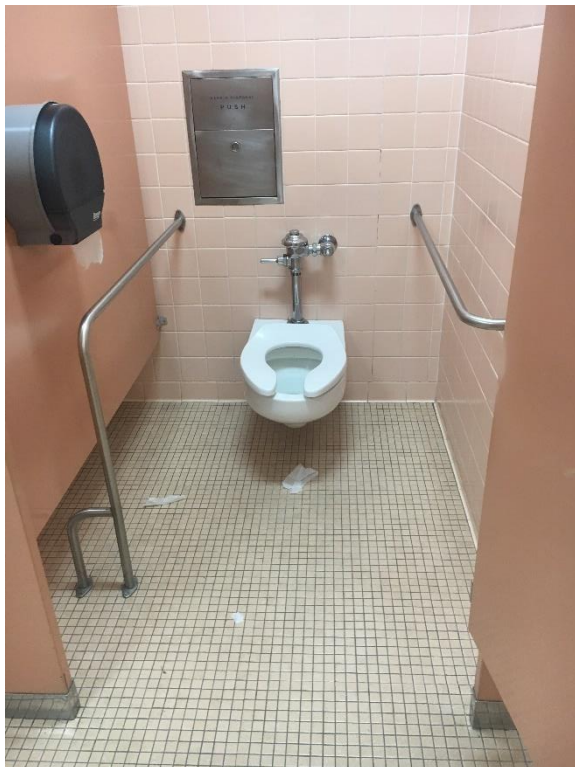
Figure 55: "Accessible" stall in Nebraska Hall with multiple incidental features, including the grab bars, door handles, and seat height. Drummy, Emily. Photograph.

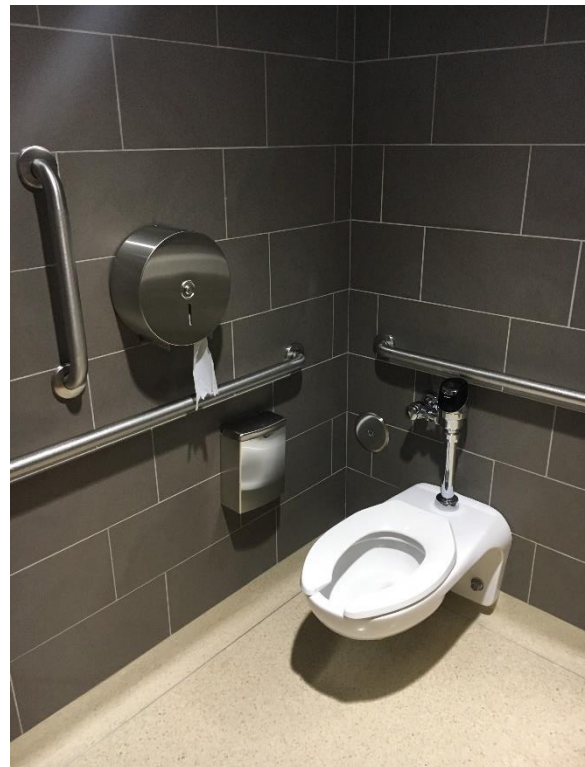
Figure 56: Truly accessible restroom in Hawks Hall. Hawks was the only building to exceed the minimum accessible stall requirement. Drummy, Emily. Photograph.
